Ears and Eyes

With Pictures

Ears and Eyes, With Pictures
Part 1/2: Belgium–Ireland
Part 2/2: Italy–Unknown country

Original publication by the No Trace Project
notrace.how/earsandeyes

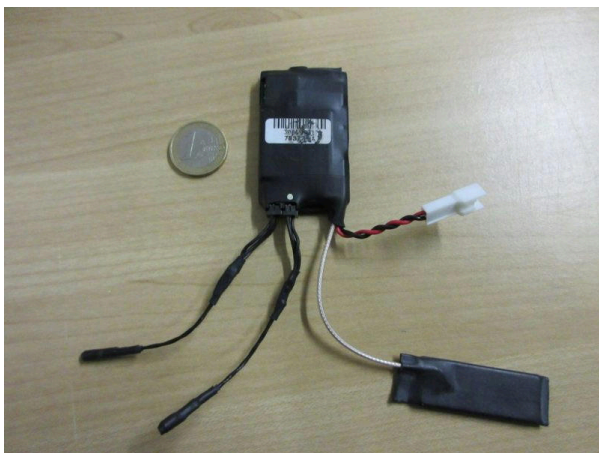
Microphones found inside a power outlet in a building in Bologna, Italy, in January 2018¹.

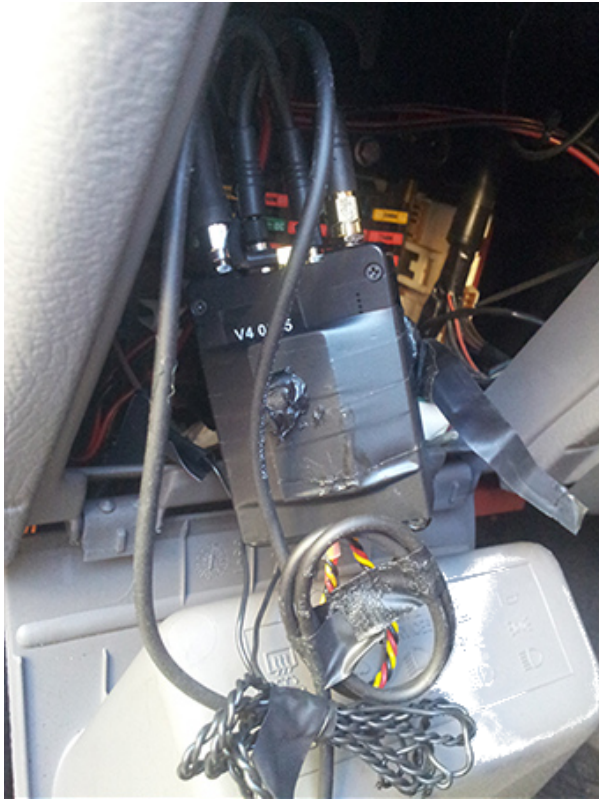
Microphones and a GPS tracker found in the fuse box of a car in Lecce, Italy, in December 2017².

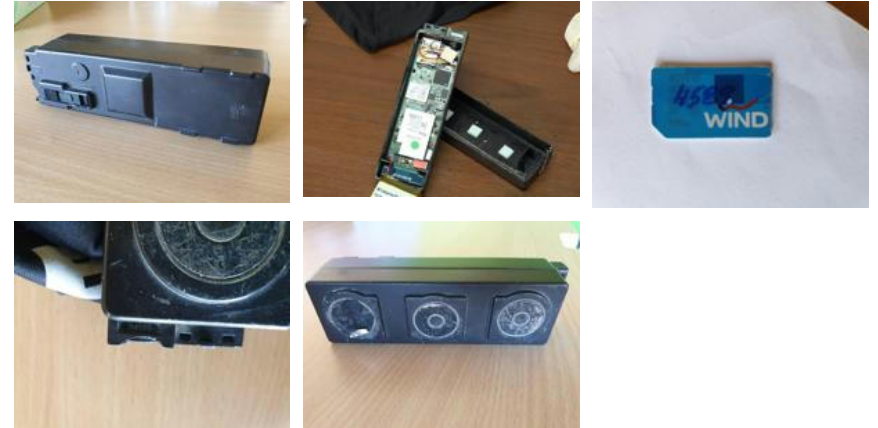
A **GPS tracker** was found on a car. It was **attached with a strong magnet**. It was equipped with a SIM card and a battery.

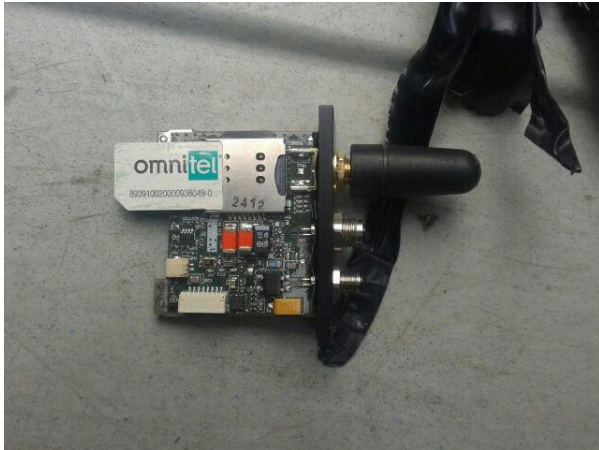
A device equipped with a SIM card found in a vehicle in Italy, in August 2019⁵.

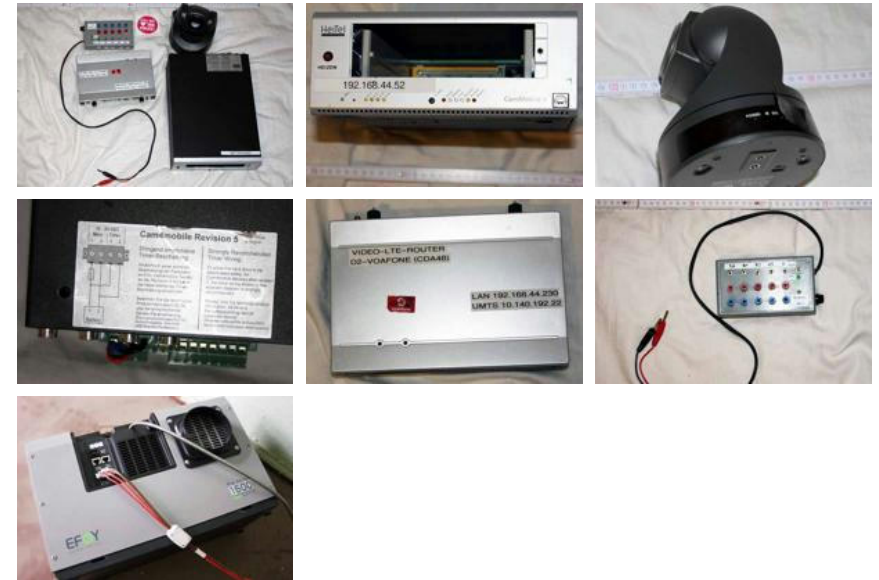
tery to power the device. Through a window, the camera had a view of the sidewalk, several building entrances and several apartment windows. The device could not be seen from the outside as luminous diodes had been specially masked off.

A video surveillance device was found in the Connewitz district of Leipzig. It was located on the second floor of a vacant house. It contained a swiveling camera which was connected to a hard disk recorder and could be controlled via an LTE mobile phone connection, and a bat-

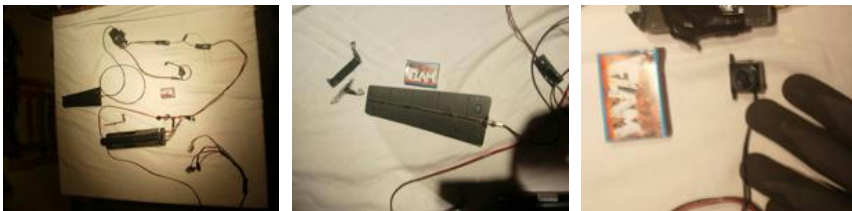
A **camera** was found at two anarchists' houses. The device was placed **in the kitchen, behind a small air vent**. It consisted in a camera, linked to a rather large battery made of 3 tubes of 4 batteries of 14.4 volts. The battery was behind the sink. Between the battery and the rest of the device was what seemed to be a switch, that could be manipulated remotely. The camera was connected to a small black box that served as an encoder. This encoder, type "Micro View Lock" (Ovations Systems), was in turn connected to what may have been an antenna to transmit images on 1.4 GHz. There was no SIM card. The camera was pointed towards the kitchen table. It was not known if it also contained a microphone. The camera was secured with magnetic elements. On almost all elements "CS" stickers were affixed. "CS" indeed matched the code of the Logistics Department of the Federal Police.

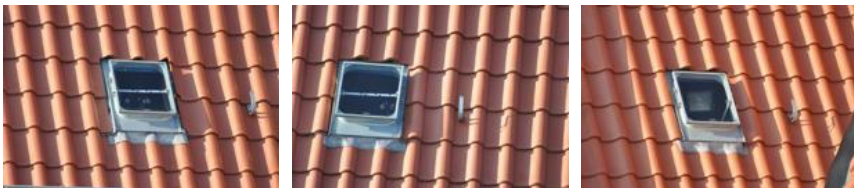
Several cameras were found in the attic of a public school located in front of a recently evicted squat, overlooking the squat through the skylights.

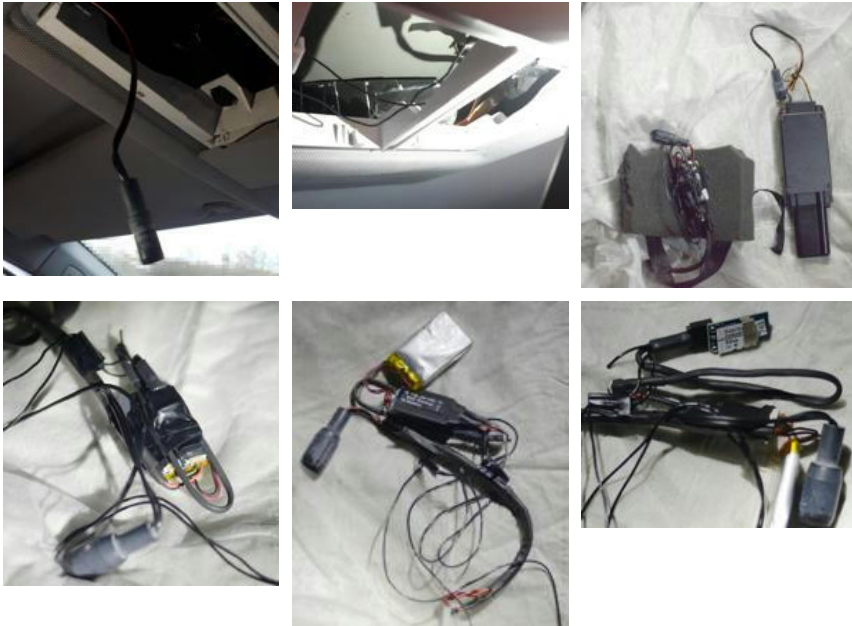
A **GPS tracker** and an **audio recording device** were found in a car. They were located **behind a panel of the front ceiling light**. They were connected by a power cable and drew their power from the supply line to the rear ceiling light. The GPS tracker contained, among other things, a GPS receiver “u-blox MAX-M8”, a card slot with a 16 GB microSD card, a cellular chip “u-blox LISA-U230” along with a Telekom SIM card, as well as a removable three-pin antenna module. The audio recording device contained a voltage converter, a 3.7 V, 550 mAh lithium-ion battery, and a small circuit board which included a 32 GB microSD card and the “NN01-104” antenna from the company Ignion (formerly “Fractus”). The audio recording device tapped into the hands-free system's existing microphone, which was located behind a cover above the rearview mirror.

Blue: microphones; Yellow: wires soldered to the power supply; Pink: small box with SIM card + SD card; Green: transformer

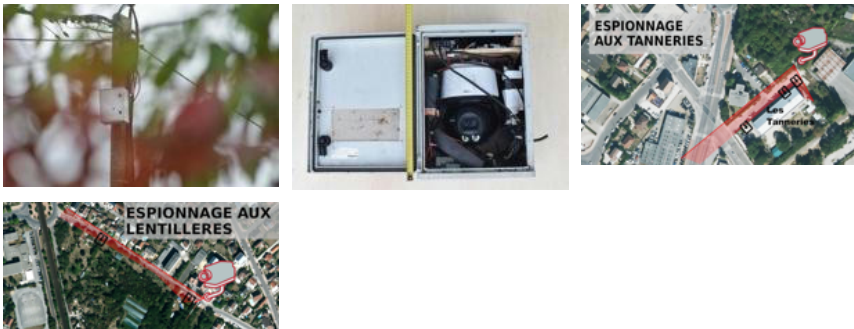
Two cameras were found in the streets, near self-managed political places. Each camera was **in a box attached to an electric pole**. They were able to film the entrances and surroundings of the places. They were present—possibly on and off—since 2019. After the discovery of the first camera, the second one was removed by the State intelligence services.
