Ears and Eyes

With Pictures

Part 1/2
Belgium–Ireland

Ears and Eyes, With Pictures
Part 1/2: Belgium–Ireland
Part 2/2: Italy–Unknown country

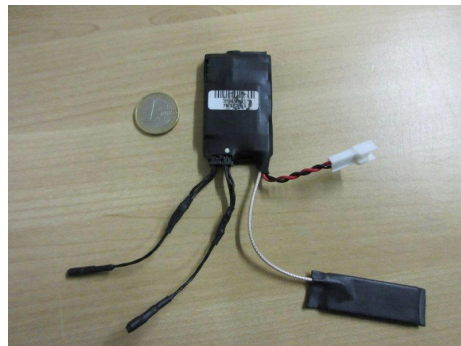
Microphones found inside a power outlet in a building in Bologna, Italy, in January 2018¹.

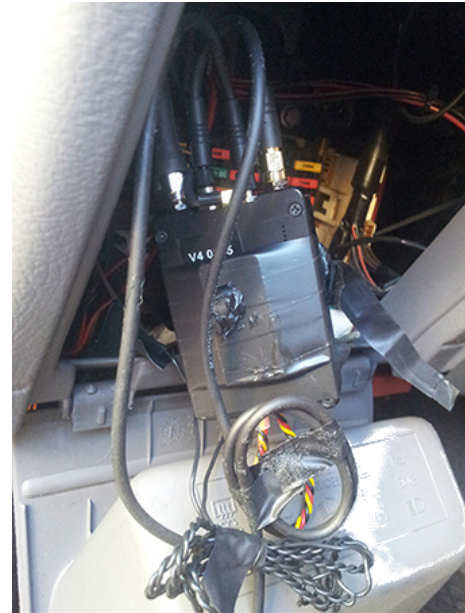
Microphones and a GPS tracker found in the fuse box of a car in Lecce, Italy, in December 2017².

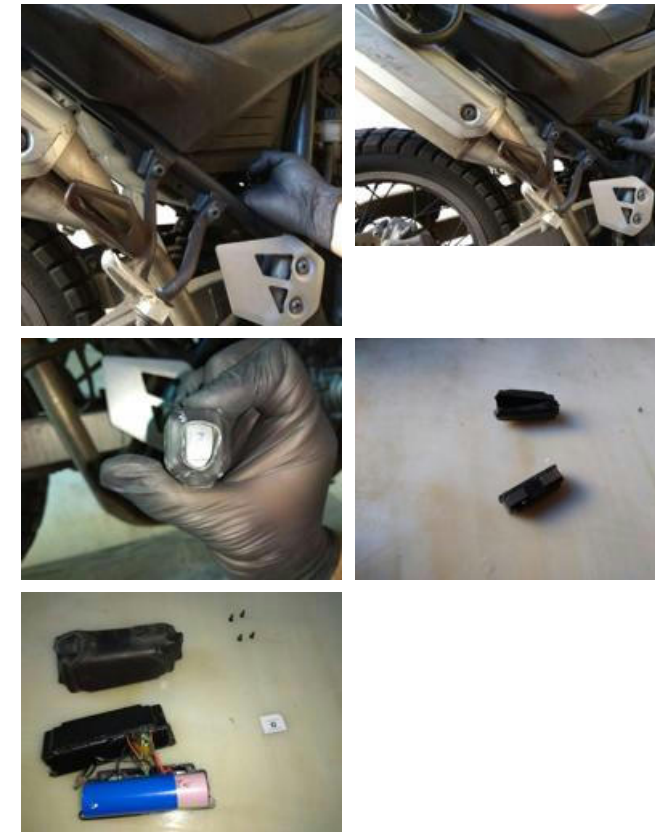
A **GPS tracker** was found on a motorbike. It was **attached with a strong magnet**. It was equipped with a SIM card and a battery.

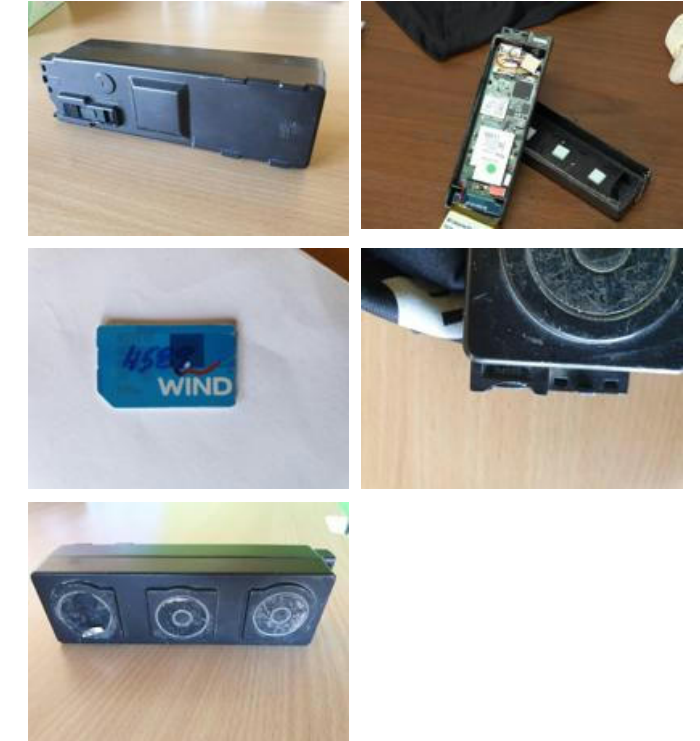
A **GPS tracker** was found on a car. It was **attached with a strong magnet**. It was equipped with a SIM card and a battery.

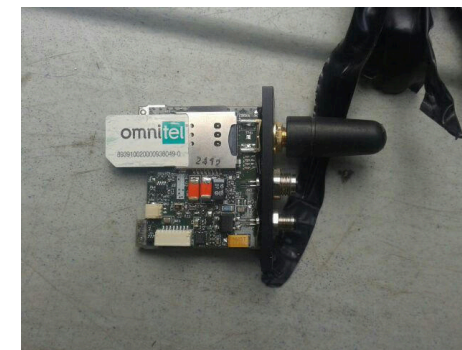
A device equipped with a SIM card found in a vehicle in Italy, in August 2019⁵.

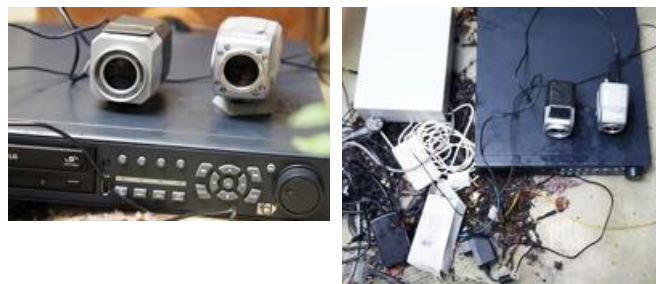
A video surveillance device was found in the Plagwitz district of Leipzig. It was located **on the second floor of a vacant house**. It contained cameras mounted on tripods, which filmed the public space through windows.

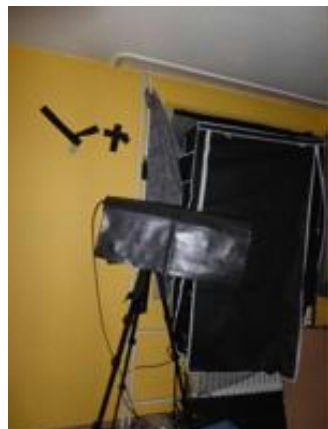
Sony camera (1)

Three surveillance cameras were found in a building, pointing towards the entrance of a *wagenplatz* (a leftist political community where people live in trailers). They were located **in a locked room, on the sixth floor of a building close to the wagenplatz**—the building in question was vacant, except for the first floor which was occupied by a leftist cultural project. One of the cameras was a “Sony ISO 409600 Extreme Sensitivity 4K” with a high-grade “Sony SEL 600mm F4 GM OSS E-mount” telephoto lens. The two other cameras were IP cameras of model “Panasonic WV-S6131”.

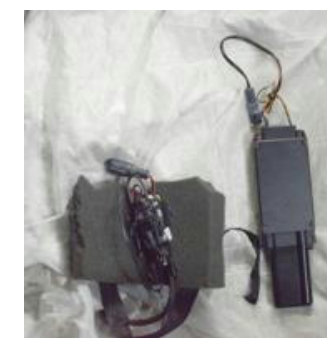
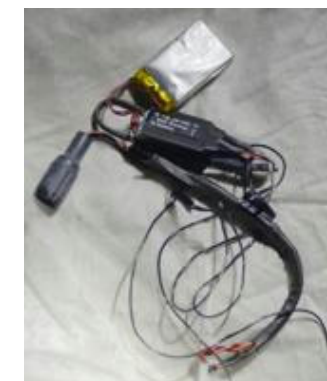
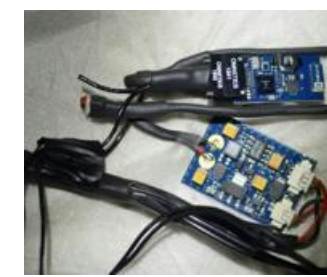
A **GPS tracker** and an **audio recording device** were found in a car. They were located **behind a panel of the front ceiling light**. They were connected by a power cable and drew their power from the supply line to the rear ceiling light. The GPS tracker contained, among other things, a GPS receiver “u-blox MAX-M8”, a card slot with a 16 GB microSD card, a cellular chip “u-blox LISA-U230” along with a Telekom SIM card, as well as a removable three-pin antenna module. The audio recording device contained a voltage converter, a 3.7 V, 550 mAh lithium-ion battery, and a small circuit board which included a 32 GB microSD card and the “NN01-104” antenna from the company Ignion (formerly “Fractus”). The audio recording device tapped into the hands-free

system's existing microphone, which was located behind a cover above the rearview mirror.

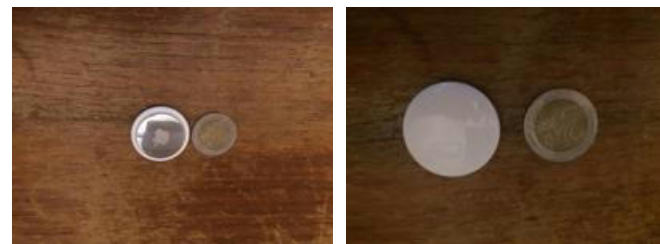
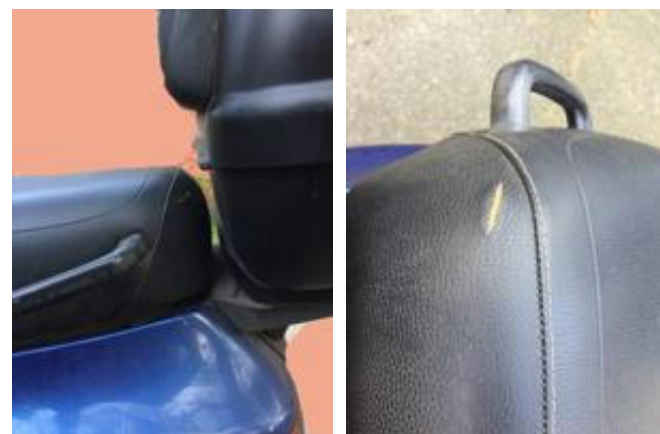
An **AirTag**—a tracking device marketed by Apple—was found on a scooter. It was hidden **inside the scooter seat cushion**, in which it was inserted through a slit apparently made with some sort of blade. It had an approximate diameter of 3 centimeters and a height of less than 1 centimeter.

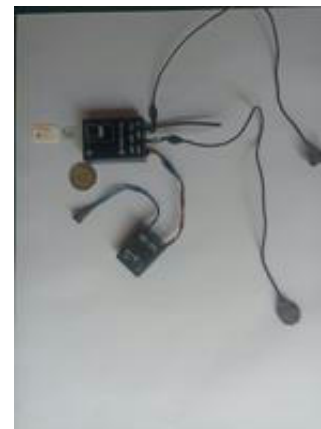
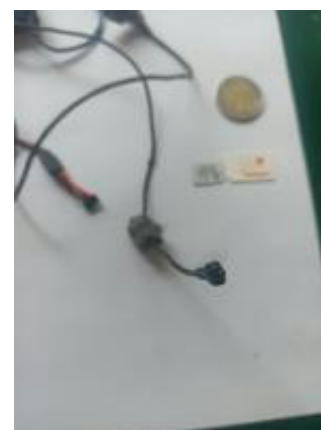
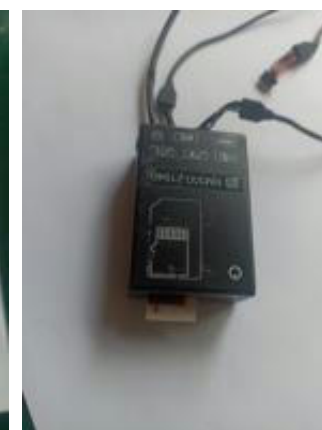
An **audio surveillance device** was found **in the Libertad anarchist library in Paris, France**. The device was hidden **inside the printer-copier of the library**. It was composed of two microphones, an antenna, a transformer, a battery, a small box containing an electronic card, a 64 GB SD card and a SIM card from the cell phone provider Orange. According to the communique which announced the discovery of the device, it was a surveillance device of model RB800 marketed by the Italian company **Innova**.

Blue: microphones; Yellow: wires soldered to the power supply; Pink: small box with SIM card + SD card; Green: transformer

- RB800-en.pdf²¹: product description of the RB800 device (in English).
- RB800-fr.pdf²²: product description of the RB800 device (in French).

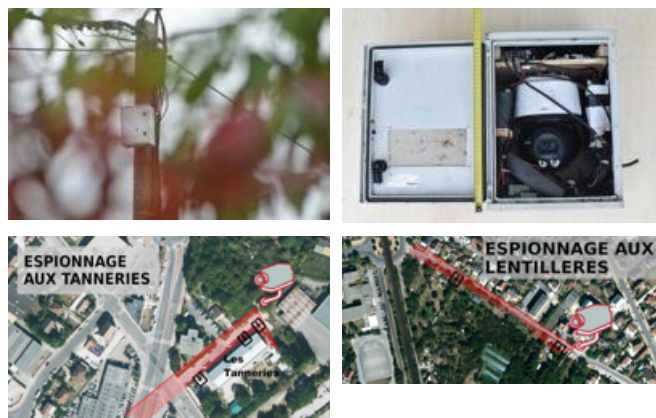
Two cameras were found in the streets, near self-managed political places. Each camera was **in a box attached to an electric pole**. They were able to film the entrances and surroundings of the places. They were present—possibly on and off—since 2019. After the discovery of the first camera, the second one was removed by the State intelligence services.

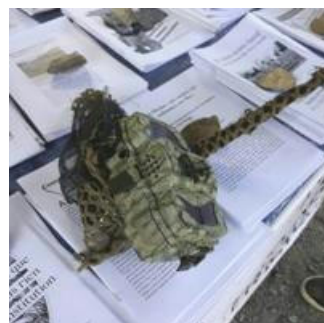
Three outdoor surveillance cameras were found outside, at an event organized in support of a struggle against a project of nuclear waste burying center. The cameras were all located **along a 250m pathway leading to the event place**. Two cameras of model BOLYGUARD MG983G were found **laying in the grass and in a bush, 80cm above ground** and were covered by a

kind of camouflage hairnet. The third camera, of model RECONYX HYPERFIRE SM750, was found **on a tree trunk, 1m20 above ground** and had a khaki color. The contents of the SD memory cards revealed several things: the devices were placed on the same day very early in the morning (between 3h30 and 4h); the three devices were capable of night vision, two of them were configured to take pictures and one to record video and sound; their placements allowed them to take pictures of the front and back license plates of cars driving on the pathway, and also of people following the pathway by foot; one of the cameras was useless because of leaves in its field of vision.

One of the two cameras of model BOLYGUARD MG983G

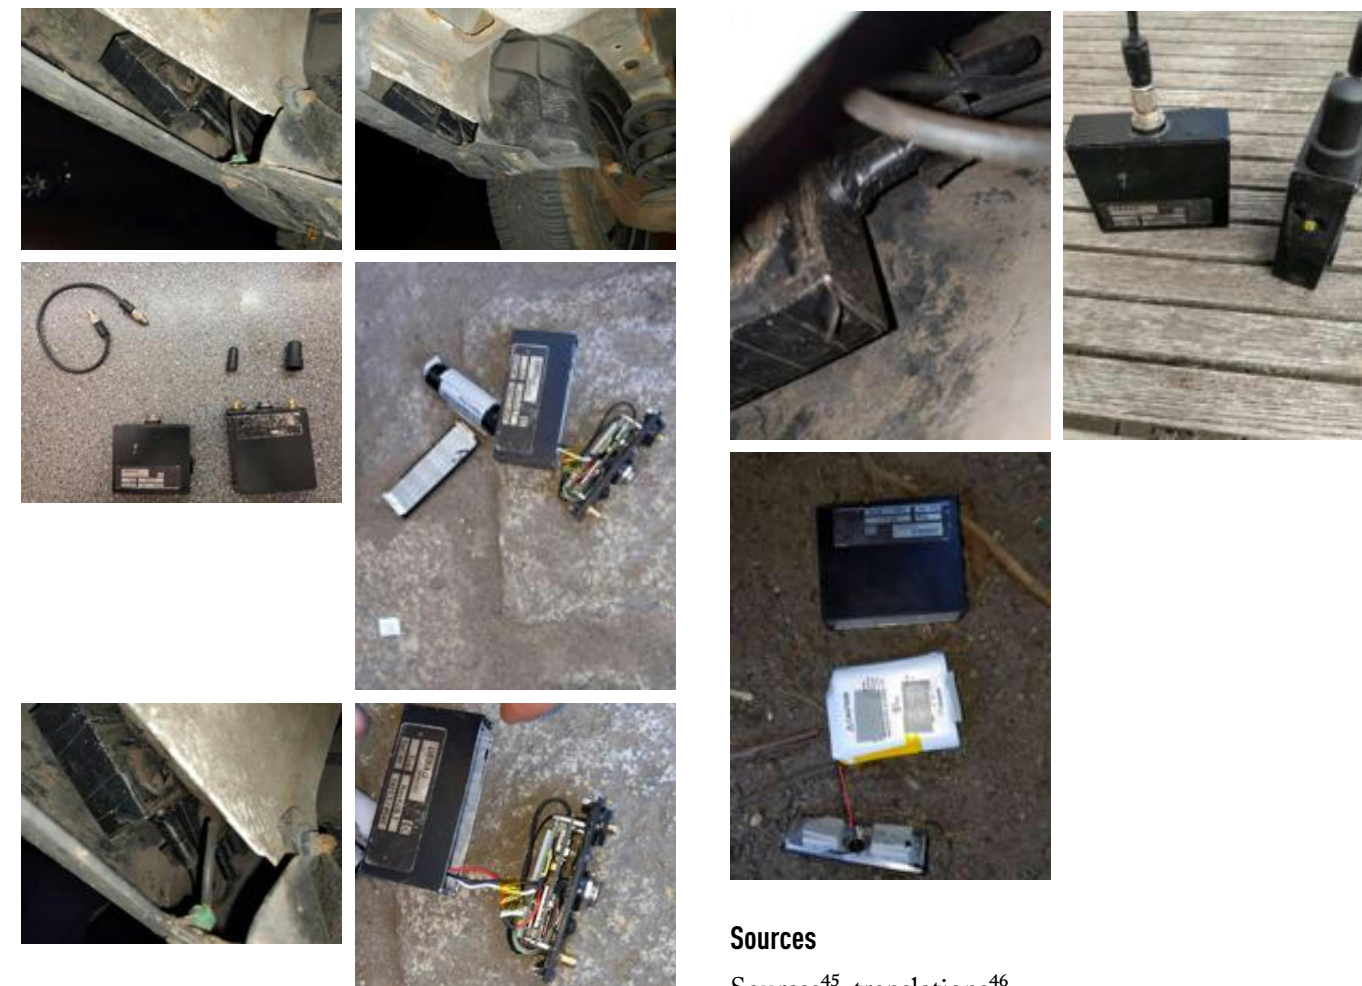
Two GPS trackers were found under a vehicle (the second one was found a few days after the first one was found and removed). They were **attached with strong magnets in a hollow space between the plastic covering of the bumper and the body, precisely behind the left rear wheel**. Each tracker consisted of two metal cases connected by a cable. The first one contained a battery pack, and the second one the tracker itself, including a smaller battery, two antennas, and a SIM card.

The pictures of the device show that a tracker of model NavKos T, marketed by the german company DESAG Telematic, was part of the device. This suggests that the device was supplied by the german company **DESAG Telematic**.

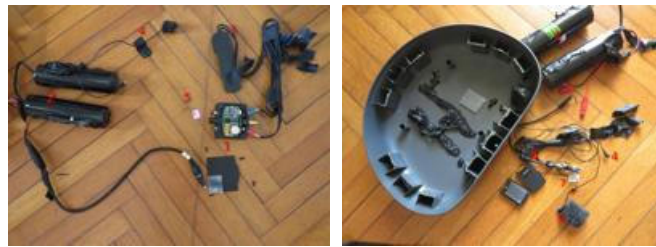
1: control unit; 2: batteries; 3: GPS antenna; 4: microphone; 5: SIM card
 2: two batteries of the listening device; 4: microphones connected to the listening device; 6: dismantled listening device; 7: SD card

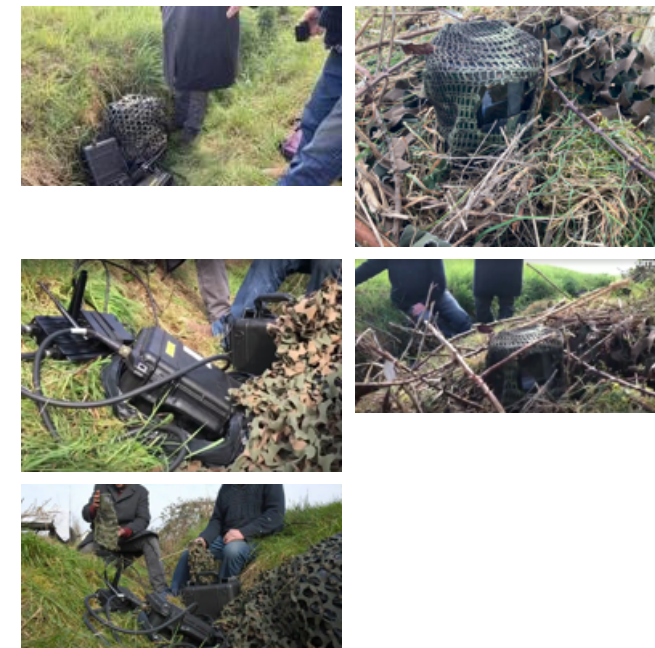
A **surveillance camera** was found **at the entrance of the village, pointed towards the home of an environmental activist. The camera, barely emerging from the ground, was covered with brambles and grass.** It was connected to a Pepwave router and to two cases containing high-tech lithium batteries labeled Accuwatt, hidden in a ditch, under a tarp and a camouflage net.

High-technology batteries found alongside the cameras were marketed by the company **Accuwatt**, specialized in batteries for armies and law enforcement agencies.

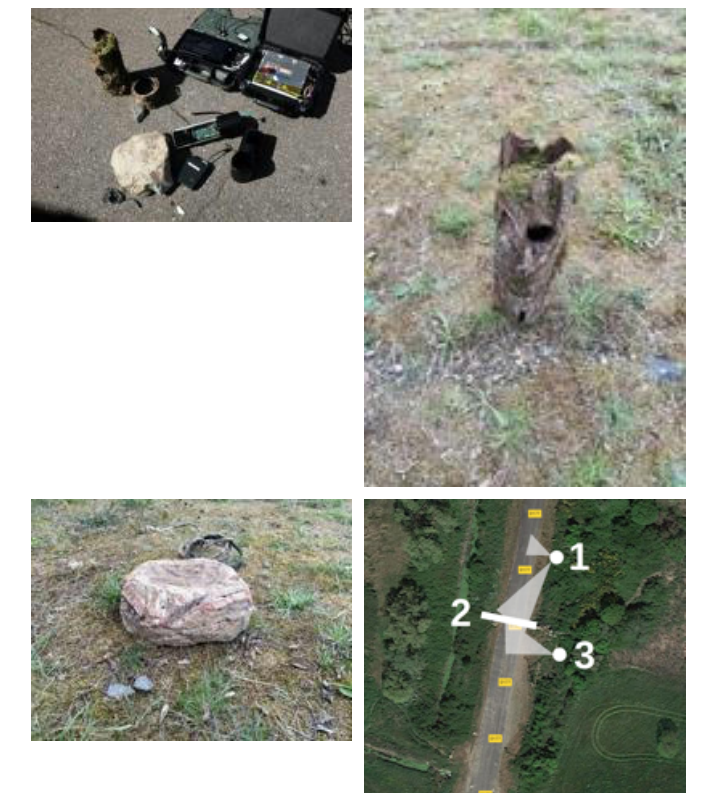
Four cameras were found near the “ZAD du Carnet”, a place of struggle against the creation of an industrial area, in Loire-Atlantique, in the west of France. The four cameras, hidden **near an access gate to the area, were camouflaged in a fake tree log and fake stones.** They filmed continuously and were connected, via buried cables, to large batteries and modems, also concealed, allowing images to be sent directly to a remote station. The mention “Allwan” was visible on some of the images found, as well as on a label on a camera. The cameras were found on August 31, and appeared to have been installed right before a “weekend of resistance” organized there on August 29 and 30.

1: first camera group; 2: portal; 3: second camera group
